PLAINS TALK

A Publication of West Plains Engineering, Inc.

June/July 2019

**Electrical Specialties
Takeover Edition**

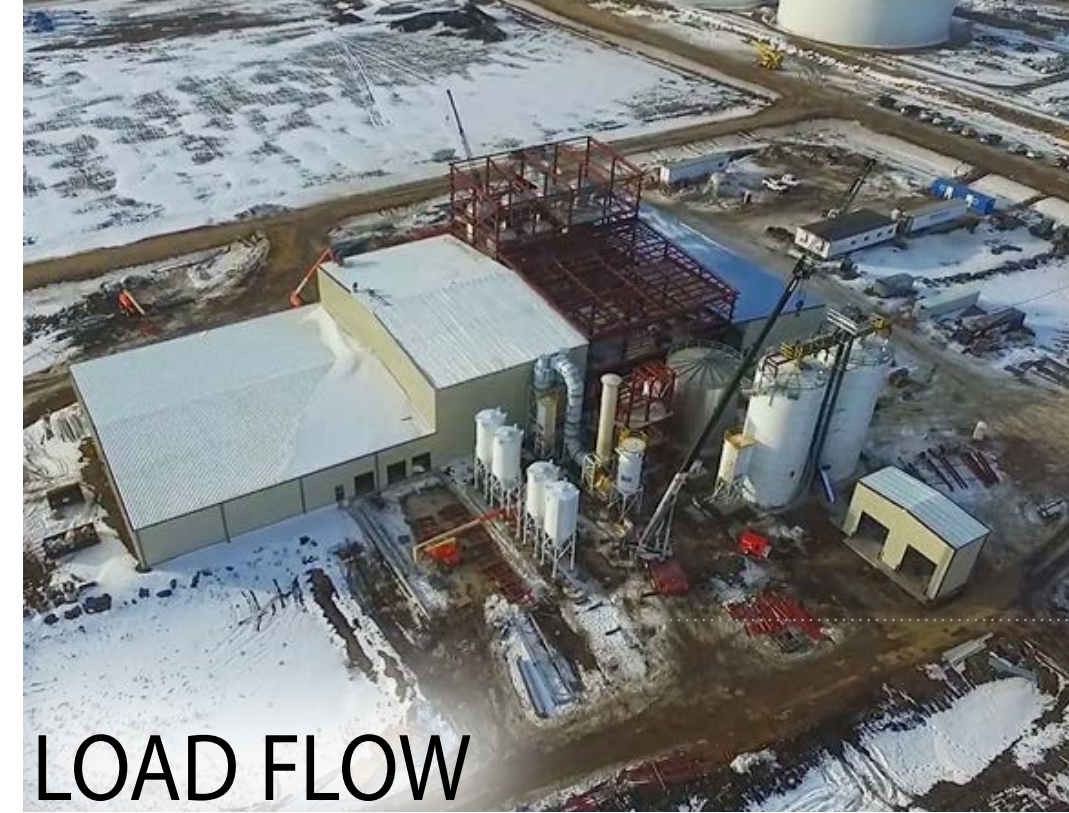
LOAD FLOW

Line Overload Report

Overload Threshold = 100.0%

Line				Load			
From Bus Name	To Bus Name	Branch Name	Rated Amps	Load Amps	Loaded%	OverLoaded%	Comment
H2	T2-P	C-T2	100.0	0.0	0.0%	-100.0%	
H3	T3-P	C-T3	100.0	0.0	0.0%	-100.0%	
H4	T4-P	C-T4	85.0	0.0	0.0%	-100.0%	
MCC2	A-750	C-A750	30.0	7.5	25.1%	-74.9%	
MCC2	A-220	C-A220	30.0	7.5	25.0%	-75.0%	
MCC2	A-230	C-A230	30.0	7.5	25.0%	-75.0%	
MCC2	P-271	C-P271	95.0	33.5	35.3%	-64.7%	
MCC2	P-990	C-P990	30.0	2.1	6.9%	-93.1%	
MCC2	A-240	C-A240	30.0	7.5	25.0%	-75.0%	
MCC2	P-210	C-P210	40.0	10.9	27.2%	-72.8%	
MCC2	P-250	C-P250	30.0	7.5	25.1%	-74.9%	
MCC2	RV-112	C-RV112	30.0	4.7	15.8%	-84.2%	
MCC2	P-750	C-P750	55.0	20.8	37.8%	-62.2%

The facility consists of three 4000 Amp services and hundreds of motors. With that many motors starting and stopping, a load flow study was imperative. The utility would only provide up to a 2500KVA transformer for each service. Total connected load is more than the switchboard capacities. The study provides real running loads, along with verification of overloads based on production sequences. Scenarios can be run to find the best load diversity over the three services and processes.
